Brand X scaler tips - Breakage study

REPORT N° A

Date: February 18th, 2013

Established by: P. REGERE - R&D Director

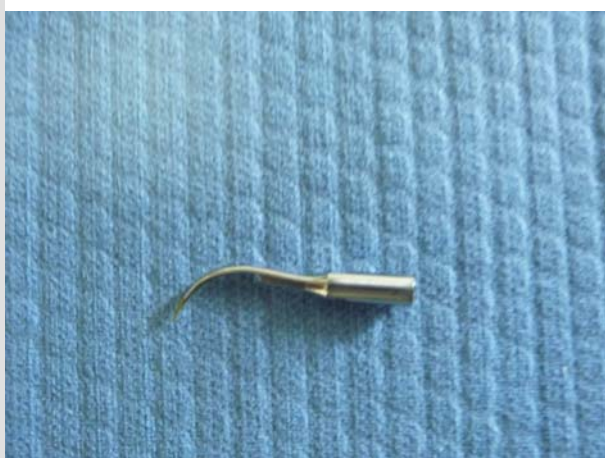
The Brand X tip tested, in appearance, is similar to the Satelec N°1 Tips, the profile configuration is very near to the Satelec tips.

Microscope inspection.

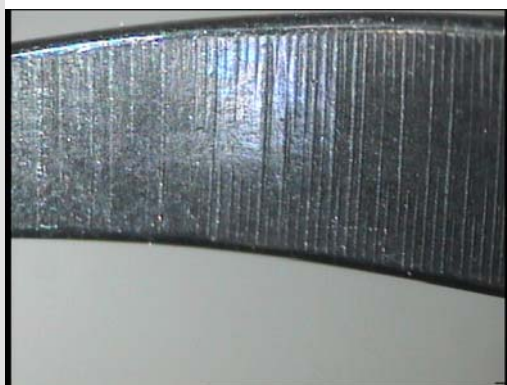
Brand X Tip

We can see that the metal aspect of the Brand X tip is not the same compared to the Satelec tip. Presence of tooling tracks on Brand X tip.

This breakage is certainly due to the multiresonance frequencies ; this tip is not adapted to a Satelec transducer and Satelec electronic power supply. The other explanation of the breakage is the presence of tooling tracks on the tip active surface.

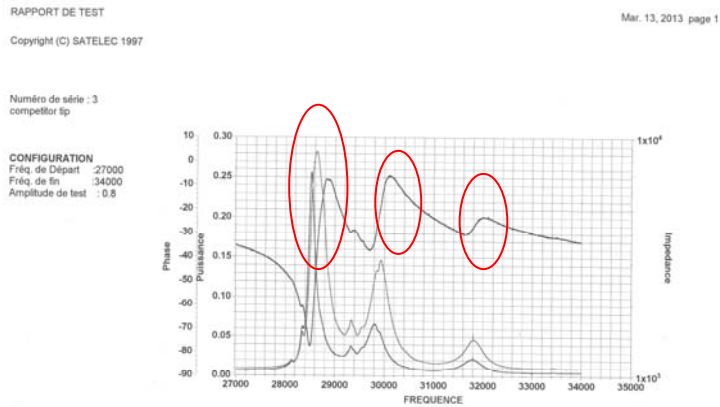
The curve obtain with the Brand X tip is the following:

We can see multiresonance frequencies with the Brand X tip around the working frequency, located between 29 and 35khz (this test has been performed with the Satelec Newtron hand piece).

The presence of multiresonance frequencies, is a risk of tip breakage. The working frequency can jump on each resonance frequency.

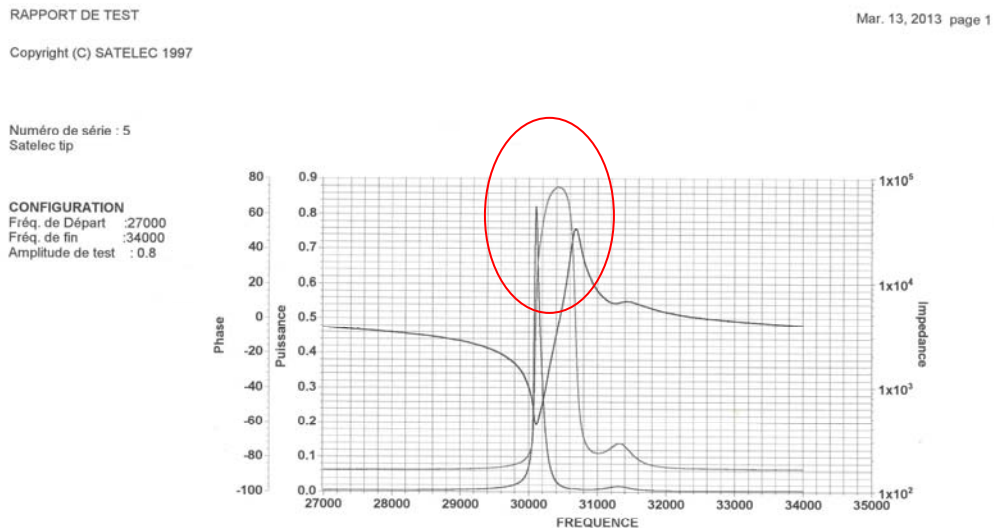
Curve obtained with the Satelec tip:

With the Satelec tips, we can see a single resonance frequency.

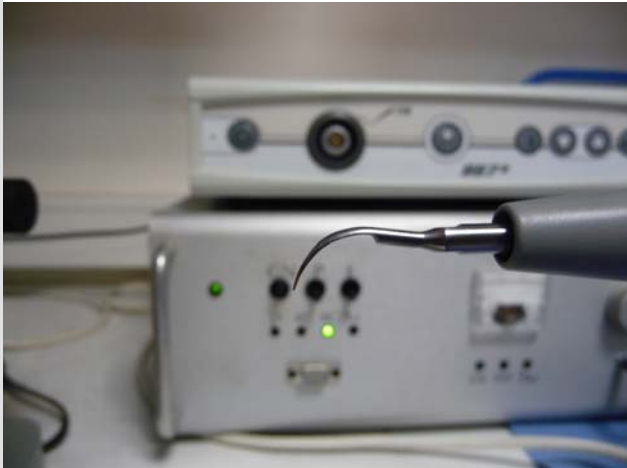
Before the test:

The Brand X tip is placed on the Satelec hand piece connected to the Satelec test bench (similar to our Satelec scaler generator). After 20 seconds, a breakage of the tip appears.

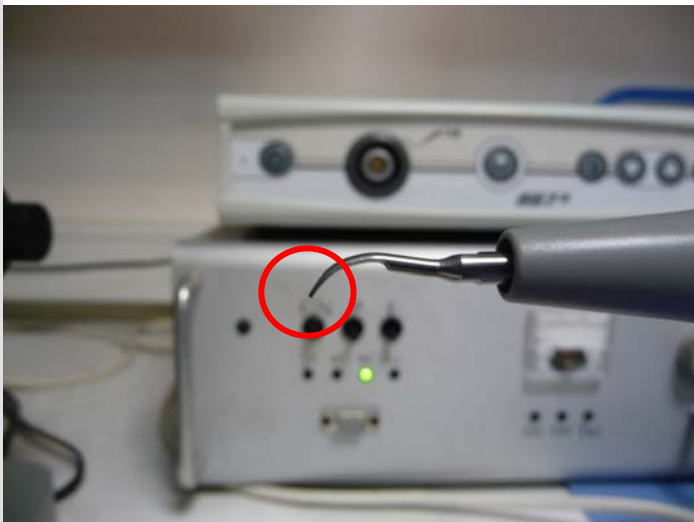
After 20 seconds of working:

We can see a tip breakage at 4 millimeters of the tip extremity (on the node of the ultrasonic wave).
