Expert report (REPORT N° C)

Product : brand X tips

Expertise objective:

- Check the resistance of brand X tips to irrigators agents;
- identification of corroded parts and risk analysis.

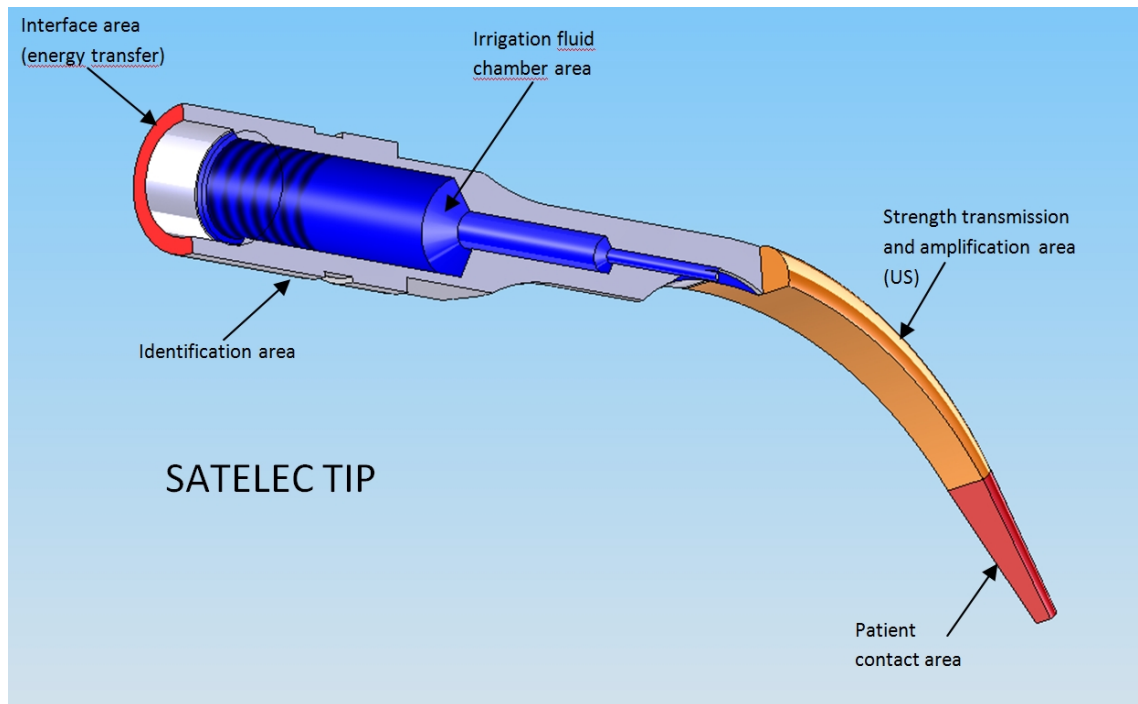
Risk analysis in association with functional areas of tips.

(example on standard tip. Every type have same functional areas)

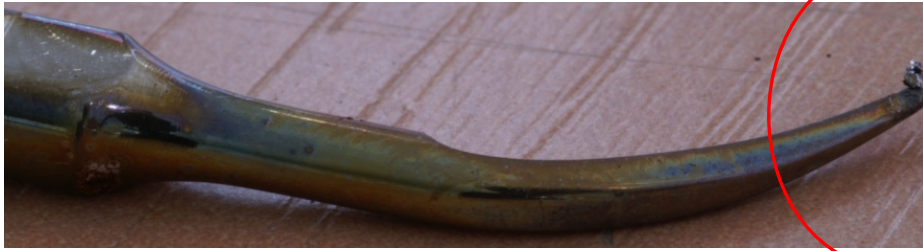
Patient contact area :

All corroded

This area in contact with patient produces the mechanical action on the treated part of the tooth. It transfers ultrasonic vibrations and thus makes the required effect, but can also contaminate the treated area due to contact and wetness of human tissues.

Therefore, the surface of this part is involved in the following risks:

- Erratic energy transfer may damage the treated surface of the patient's tooth (percussion effect, effect of excessive abrasion) due to inadequate form, a non-smooth surface or corroded;
- In opposite, ineffectiveness (no sharp edge, rapid wear) can induce longer use and lead to overheating of the tissue in contact.
- Lack of control of displacements due to the alteration of the shape of the tip inducing intensive application or otherwise insufficient application (not homogeneous);
- Transfer to the patient's body chemical residues produced by the corrosion of the steel used. These products are oxides and chlorides and depends on the action of the irrigator on the alloy steel of poor quality, and may be water soluble and therefore transmitted in all aqueous fluids (saliva, blood, ...)

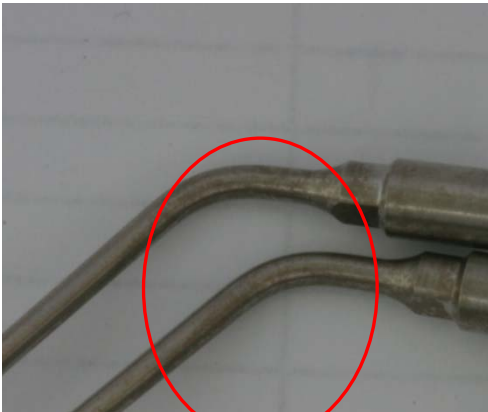
Strength transmission and amplification area (US)

All corroded

This zone is subjected to vibrations at 29000 Hz with amplitudes of 10 to 150 μ m (pp) in bending. The resistance of this zone to high frequency accelerations determines the non-breaking of tips, the risk of fatigue breaking being initiated by a weakness of the material.

Cracks and fissures in steel are the starting point of this type of failure. As such, the rugosity of the surface should be as low as possible.

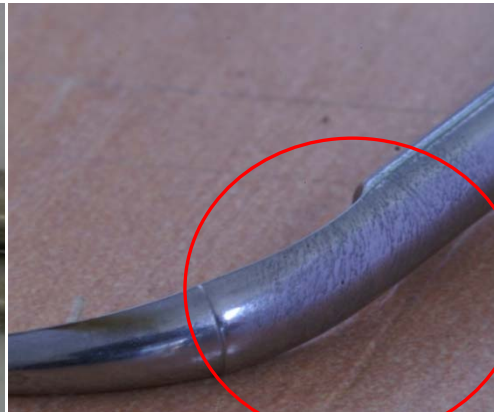
Cracks, fissure and corrosion

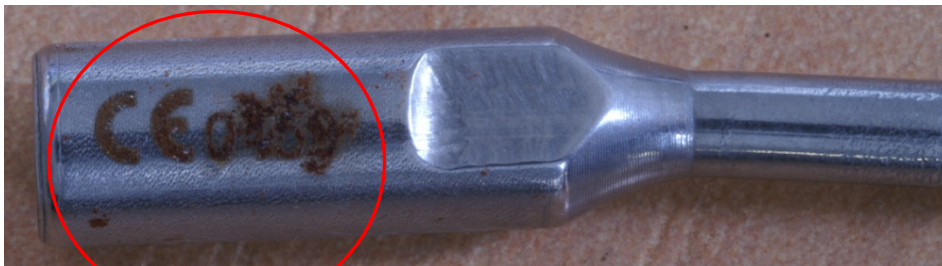
Identification area

Not readable

This area is dedicated to marking the tips, not only from the mandatory point of view, but mainly gives information to select the appropriate power.

Using a tip on an inappropriate range can result in break during use in the patient's mouth.
